National Construction Safety Team Investigation

The Station Nightclub Fire

NCST Advisory Committee June 22-23, 2004

Egress study -

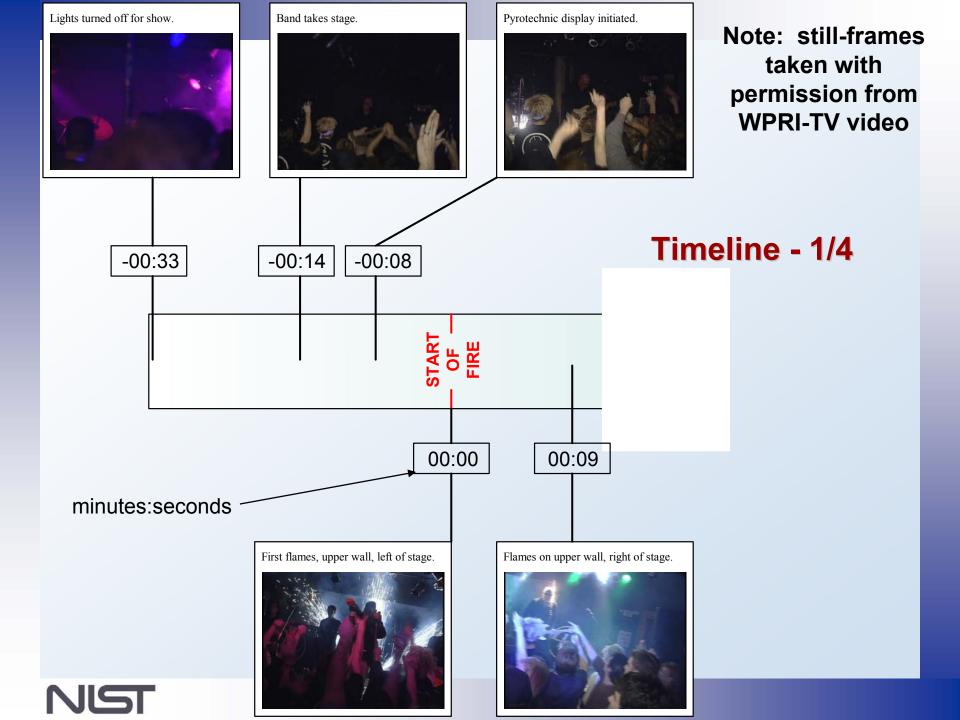
Video Time	Fire Time	Description
0:05:49	- 0:00:33	Stage lights turned off for beginning of show.
0:06:08	- 0:00:14	Band first shown on stage.
0:06:14	- 0:00:08	Pyrotechnic display initiated.
0:06:22	0:00:00	First flames on upper wall, left of stage.
0:06:31	0:00:09	Flames on upper wall, right of stage. Pyrotechnic display ends.

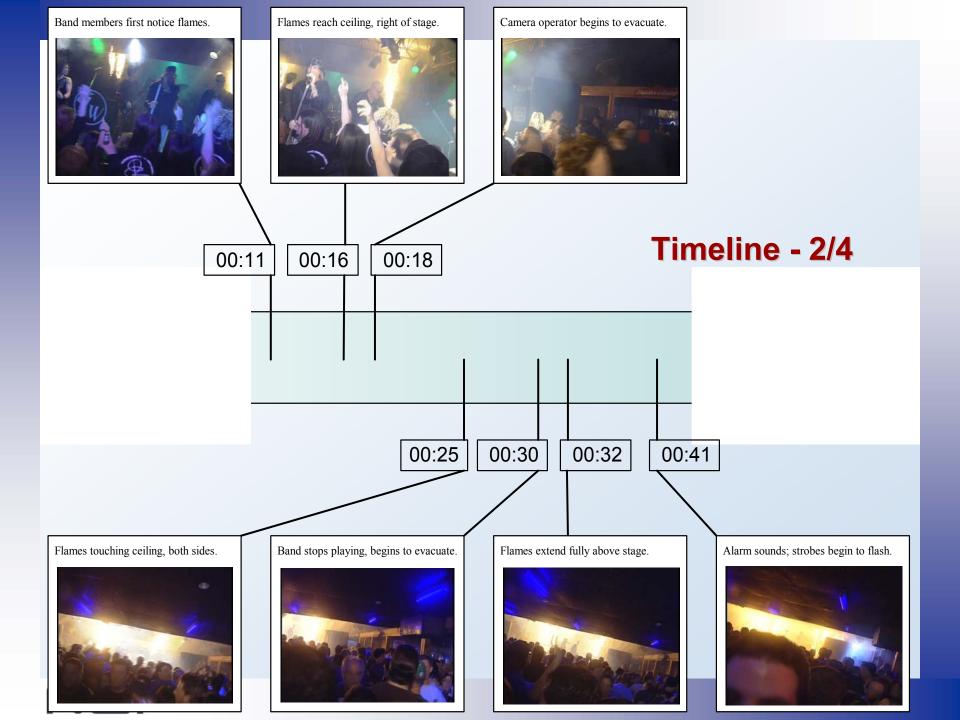
Video Time	Fire Time	Description
0:06:33	0:00:11	Band members first notice flames.
0:06:38	0:00:16	Flames reach ceiling to right of stage.
0:06:40	0:00:18	Camera operator begins to evacuate.
0:06:47	0:00:25	Flames touching ceiling on both sides of stage.
0:06:52	0:00:30	Band stops playing, begins to evacuate.
0:06:54	0:00:32	Flames extend fully across ceiling above stage.
0:07:03	0:00:41	Fire alarm sounds and strobes begin to flash.

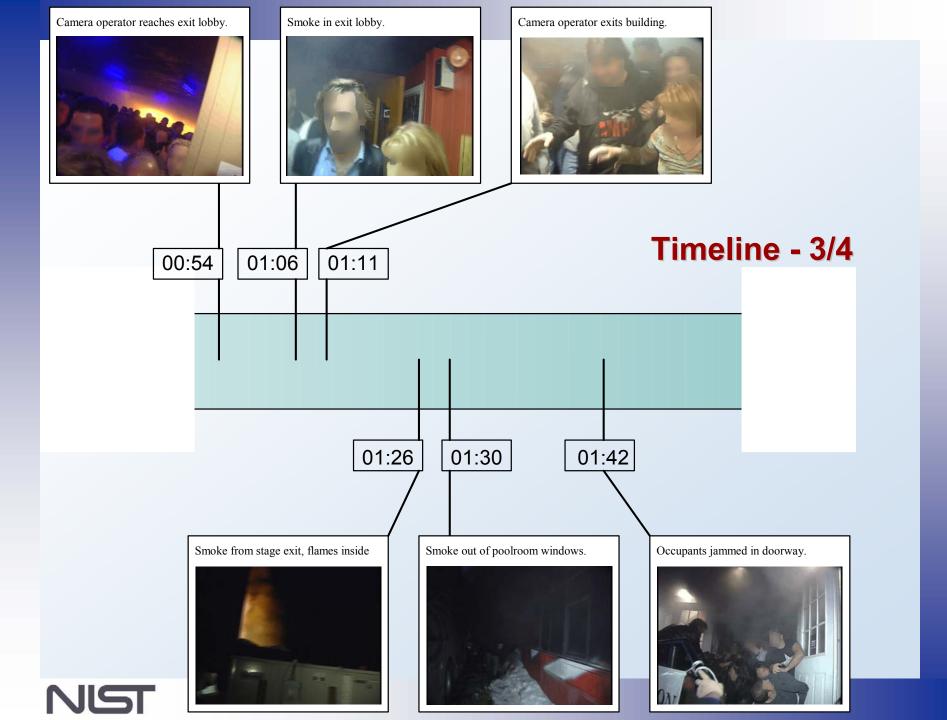
Video Time	Fire Time	Description	
0:07:16	0:00:54	Camera operator reaches exit lobby.	
0:07:28	0:01:06	Smoke in outer exit lobby.	
0:07:33	0:01:11	Camera operator exits building.	
0:07:48	0:01:26	Smoke coming out of stage exit. Flames visible inside at this location.	
0:07:52	0:01:30	Thick black smoke from pool room windows. Smoke appears to be at floor level inside. Occupants egressing through windows.	
0:08:04	0:01:42	Camera operator returns to main exit. People piled up in doorway. Smoke pouring out above people.

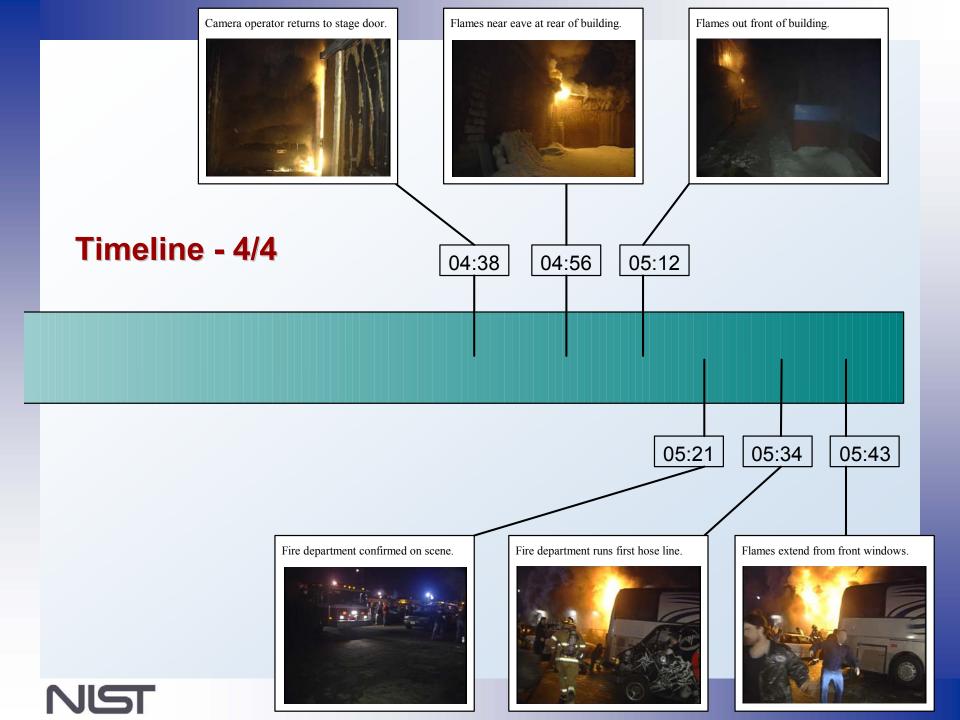
Video Time	Fire Time	Description
0:11:00	0:04:38	Camera operator returns to stage exit. Smoke ~1 ft above floor inside. Flames near door.
0:11:18	0:04:56	Flames outside building at roof level in rear.
0:11:34	0:05:12	Flames first recorded out front of building.
0:11:43	0:05:21	Fire department confirmed on scene.
0:11:56	0:05:34	Fire department commences running first hose line. Flames extending from main exit ~8-10 ft.
0:12:05	0:05:43	Flames extend from front windows.
